# Section 19 Flood Investigation Report

## South Tottenham, London Borough of Haringey

M01600-15\_DG01 | January 2022

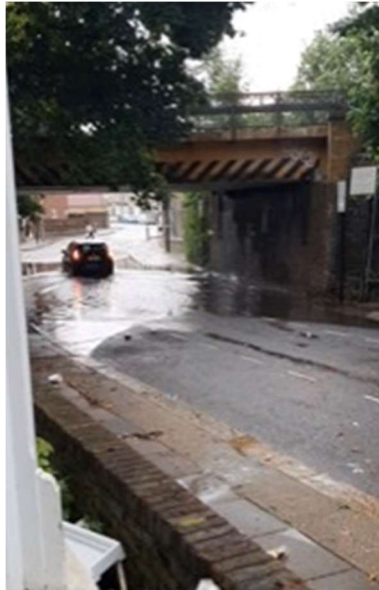
LFB received flood related emergency calls from 16:16pm. Calls were received from St Loys Road, Stoneleigh Road and Woodside Gardens. Both residential dwellings and business were affected. Haringey Council received further calls from properties on Albion Road, Dowsett Road and Forster Road. At least 10 businesses along High Road experienced minor flooding of their premises. During a site walkover visit on 28<sup>th</sup> October 2021, local business owners on Moorefield Road off High Road described flood waters covering the highway on the southern end of Moorefield Road and St Loys Road.

**Figure 5-3 Flooding at Forster Road underpass, 25th July 2021**

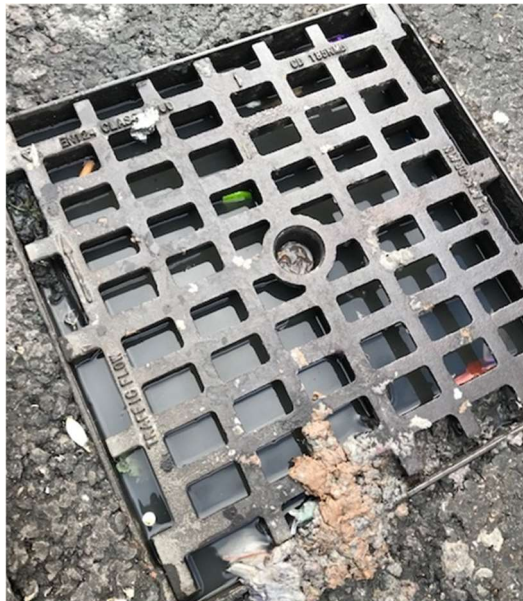
A site walkover on 28th October 2021 showed that at least 2 no. gullies along a 100m stretch of the road were blocked. Any blockages would have reduced the capacity for surface water to enter reach the public sewer.

**Figure 5-4 Blocked gully outside 490 High Road, 28th October 2021**

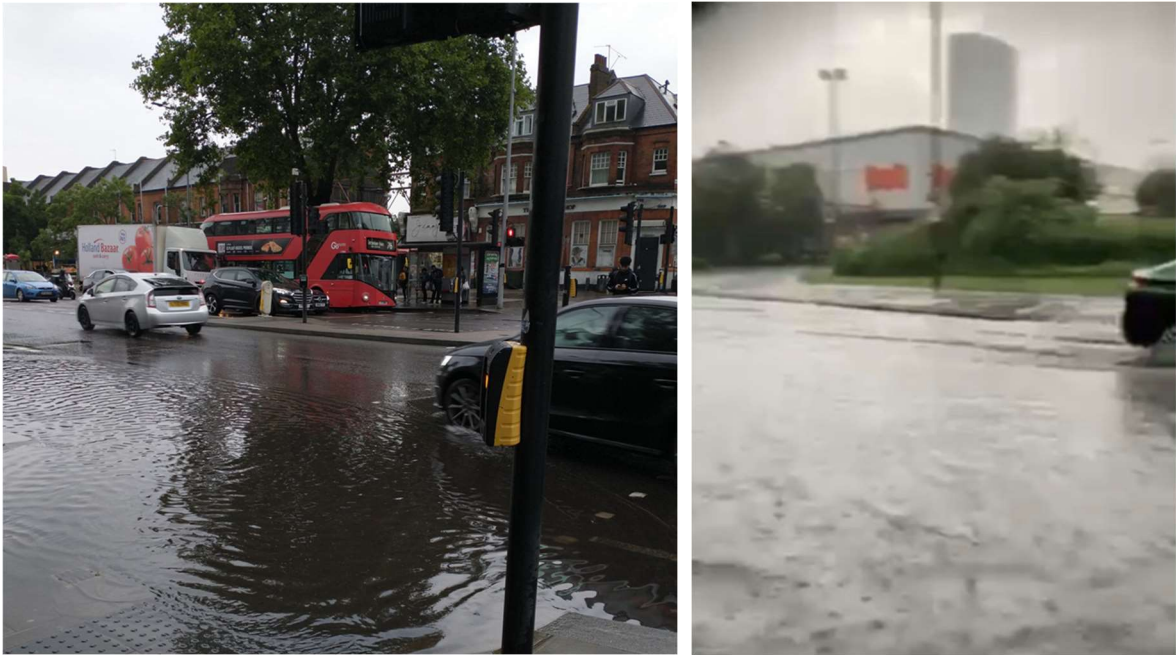
**Figure 5-6 Flooding in Broad Lane, South Tottenham, 25th July 2021**

In Broad Lane and Markfield Road, the topography, existing sewer and culvert network (and DWMP outputs) and connections to the River Lee suggests that the primary cause of flooding was excessive rainfall which exceeded the capacity of the drainage network in the area. The rise in water levels in the River Lee would have increased surcharging of the sewer and culvert network; this in combination with the intensity of the rainfall meant that it accumulated on the surface, flooding the carriageway.

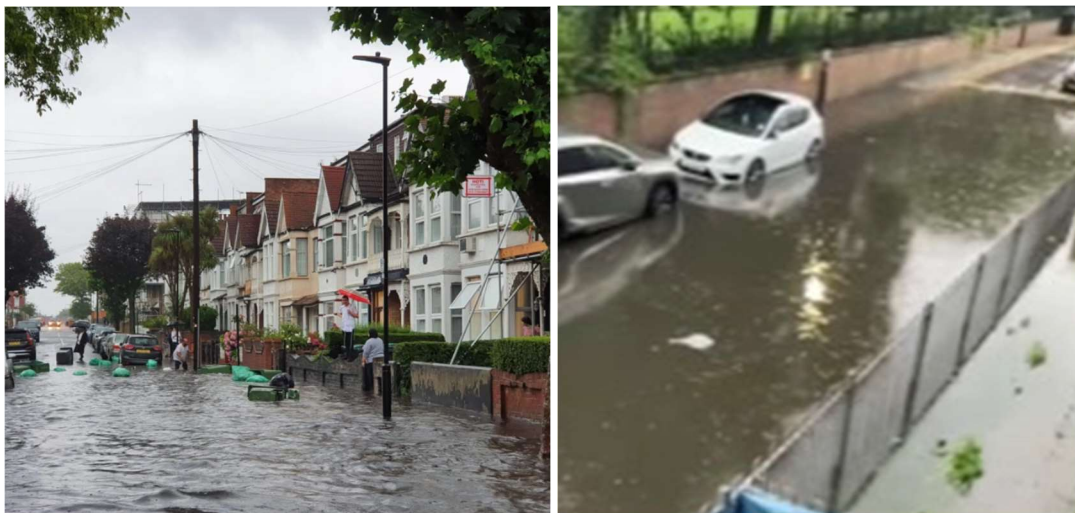
**Figure 5-7 Flooding in Elm Park Avenue (L) and Lemsford Close, South Tottenham, 25th July 2021**

In Elm Park Avenue and the neighbouring streets, the photographs and DWMP outputs strongly suggest that the primary cause of the flooding was the limited receiving capacity of the sewers. The intensity of the rainfall meant that surface water was unable to enter the sewer network fast enough and accumulated in the topographical low sections of Elm Park Avenue, Clifton Gardens, Grovelands Road and Lemsford Close.

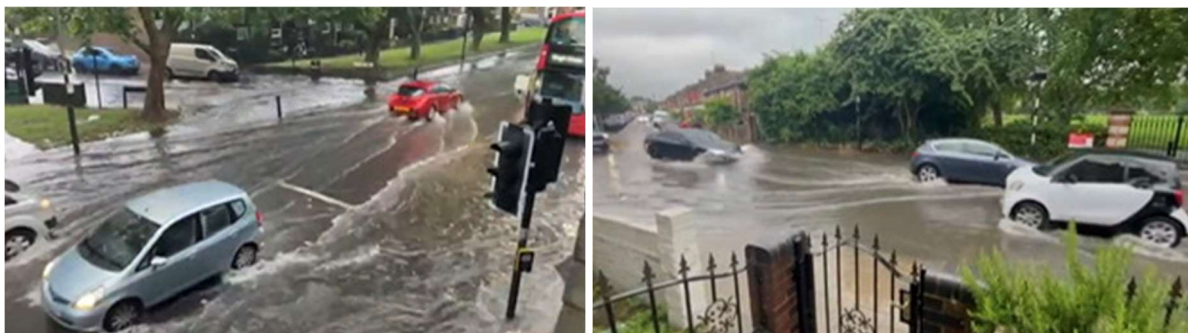
Figure 5-9 Flooding on Seven Sisters Road (L) and Black Boy Road, 25th July 2021

The photographs, flood reports and DWMP output strongly suggest that the primary cause of the flooding was an exceedance of the capacity of the drainage network and culverts in this area, caused by the excessive rainfall which fell on the day. The intensity of the rainfall meant that surface water was unable to enter the sewers and culverted watercourses fast enough and accumulated in the topographical low points, flooding the highways and adjacent properties. The DWMP model outputs suggest that the limited receiving capacity

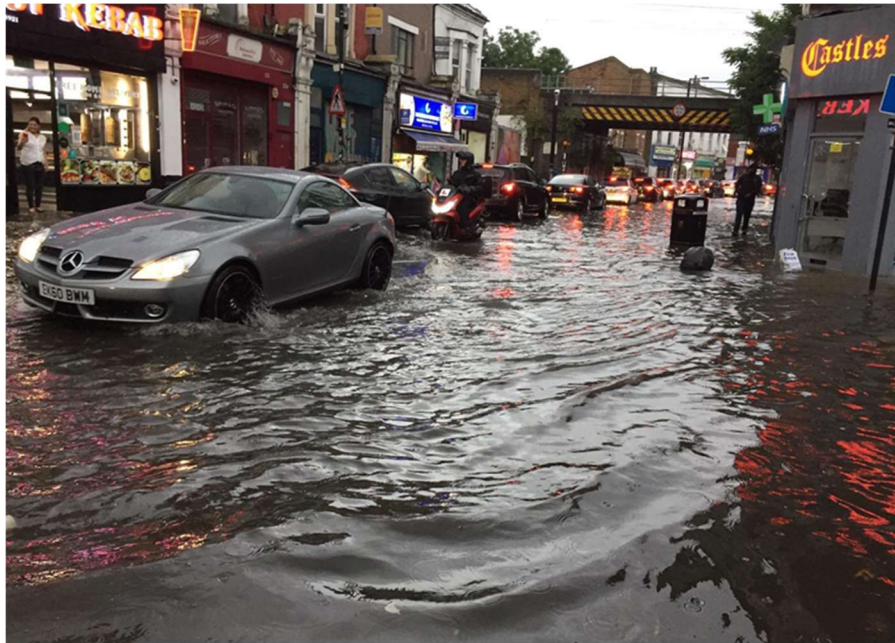
**Figure 5-11 Flooding on West Green Road, 25th July 2021**

The photos and site evidence strongly suggest that the primary cause of the flooding was exceedance of the capacity of the surface water sewers in West Green Road. Surface water was unable to enter the sewer network fast enough and accumulated in the low-lying area along West Green Road, which reached sufficient depths to flood the highway and enter property. The DWMP model outputs suggest that the limited receiving capacity of the sewers would have been the primary cause of flooding. Observations during the site walkover support this; frequent gully positions were identified at the low spot of the railway underpass (14 no. across 12m of carriageway) but flooding was not prevented. Further investigation would be required throughout this low lying section of West Green Road to identify whether the capacity issues were entirely due to the receiving capacity of the public sewer or whether the capacity of the highway drains was a contributing factor. Other contributing factors to the extent (depth and magnitude) of flooding include:

The photographs from the flooding along West Green Road shows vehicles moving through the flood water, which in other instances across Haringey during the July floods, have caused a bow wave effect. This could have led to further movement of water onto the footway and into properties.

- Haringey Council to consider localised temporary road closures or diversions in high-risk areas with low profile kerbs to reduce ingress of floodwaters onto footways and into properties where risk of internal flooding is caused by bow wave affect from the movement of vehicles through flood waters.

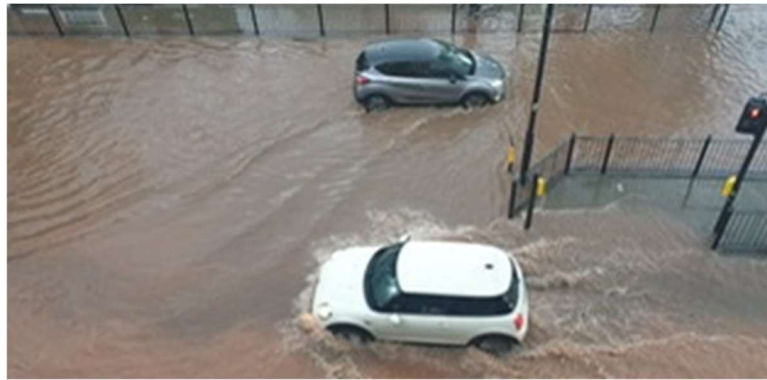
**Figure 5-13 Flooding at Green Lanes, 25th July 2021**

The photos and flood report schedule suggests that the primary cause of the flooding was exceedance of the capacity of the surface water sewers in Green Lanes. Surface water was unable to enter the sewer network fast enough and accumulated in the low-lying area along West Green Road, which reached sufficient depths to flood the highway and businesses. The DWMP model output shows a risk of surface water escaping from manholes during a 1 in 30 year event. This is supported by the flood report of manholes being lifted. Further investigation would be required in throughout the section of Green Lanes south of the underpass to identify whether the capacity issues were entirely due to the receiving capacity of the public sewer or whether the capacity of the highways was a contributing factor.

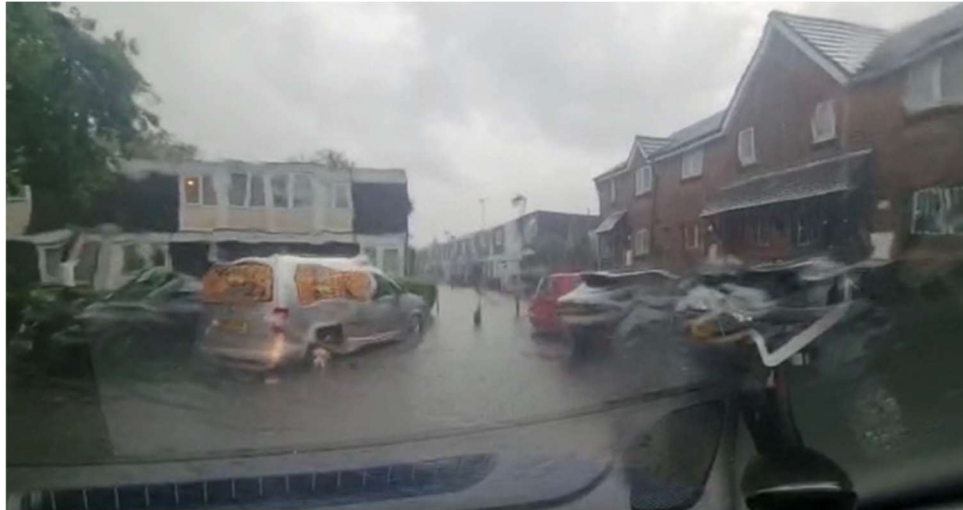
**Figure 5-15 Flooding on Milton Road Estate, 25th July 2021**

The photos, anecdotal evidence and output from the DWMP strongly suggest that the primary cause of the flooding was excessive rainfall which exceeded the capacity drainage network in this area. The intensity of the rainfall meant that surface water was unable to enter the sewer network fast enough and accumulated in the topographical low points, which flooded highways and properties. Further investigation would be required in the east of Langham Road to identify whether the capacity issues were primarily due to the receiving capacity of the highway drains, the public sewer or both.

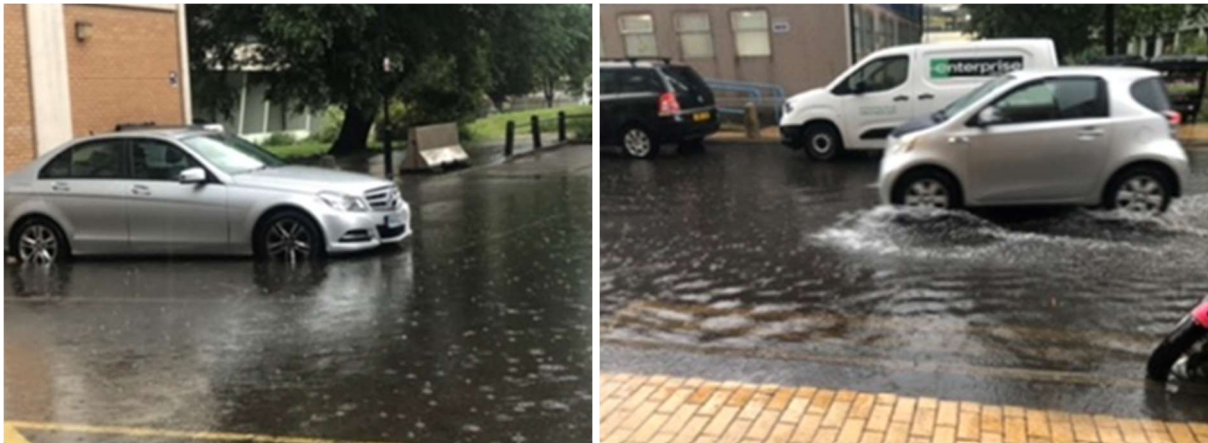
**Figure 5-17 Flooding at Broadwater Farm, 25th July 2021**

The photos, topography and location of the watercourses suggests that the primary cause of the flooding was excessive rainfall which exceeded the capacity of the drainage network and/or culverted watercourse in this area. The intensity of the rainfall meant that surface water was unable to enter the sewers or culverts fast enough, resulting in an accumulation of water in the topographical low points, which reached sufficient depths to flood the carriageway and enter property. The DWMP model output suggests that the limited receiving capacity of the sewers on would have been the primary cause of flooding on Willan Road. Further investigation would be required to identify whether the capacity issues were primarily due to the receiving capacity of the highway drains, the public sewer, the culvert or a combination.

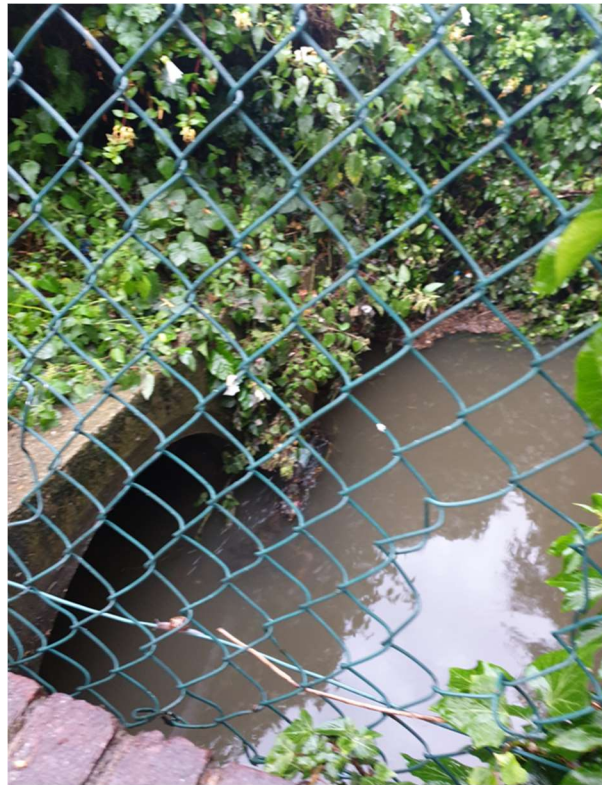
Haringey Council received reports of flooding in the highway at Larkspur Close on 12<sup>th</sup> July. Haringey Council visited the area at 21:00pm, by which time the flooding had largely receded. It was confirmed to Haringey Council that the floodwaters reached kerb level. The rain stopped before property was flooded but residents had placed sandbags at their front doors in preparation. Responders from Haringey Council noted from their visit a build-up of vegetation at the culvert inlet of the Lesser Moselle watercourse.

**Figure 5-19 Moselle Culvert at Larkspur Close, 12th July 2021**

The site visit notes, flood report schedule and existing drainage arrangement strongly suggests that the primary cause of the flooding was exceedance of the capacity of the Lesser Moselle, caused by excessive rainfall. The intensity of the rainfall meant that capacity of the sewer network was overwhelmed and started to accumulate in the topographical low points, flooding the carriageways in Larkspur Close.

Haringey Council visited the area on the evening of 12<sup>th</sup> July and noted heavy vegetation at the inlet of the Lesser Moselle Culvert inlet. Haringey Council has stated via email that at times of heavy rain debris from upstream reduces the capacity of the culvert inlet.

- It is noted that Haringey Council is progressing a flood resilience / protection scheme at Larkspur Close which will comprise installation of rain gardens within existing green spaces within the Close, installation of a flood retention basin within the green space located at the junction of Fryatt Road and Jellicoe Road, installation of a demountable flood gate at the entry to Larkspur Close and installation of non-return valves at the gully outlet points from Larkspur Close to Moselle Brook along with other ancillary works. The scheme is currently at design stage and no defined date for installation has been provided.
