Section 19 Flood Investigation Report

Wood Green

London Borough of Haringey

M01600-13_DG01 | January 2022

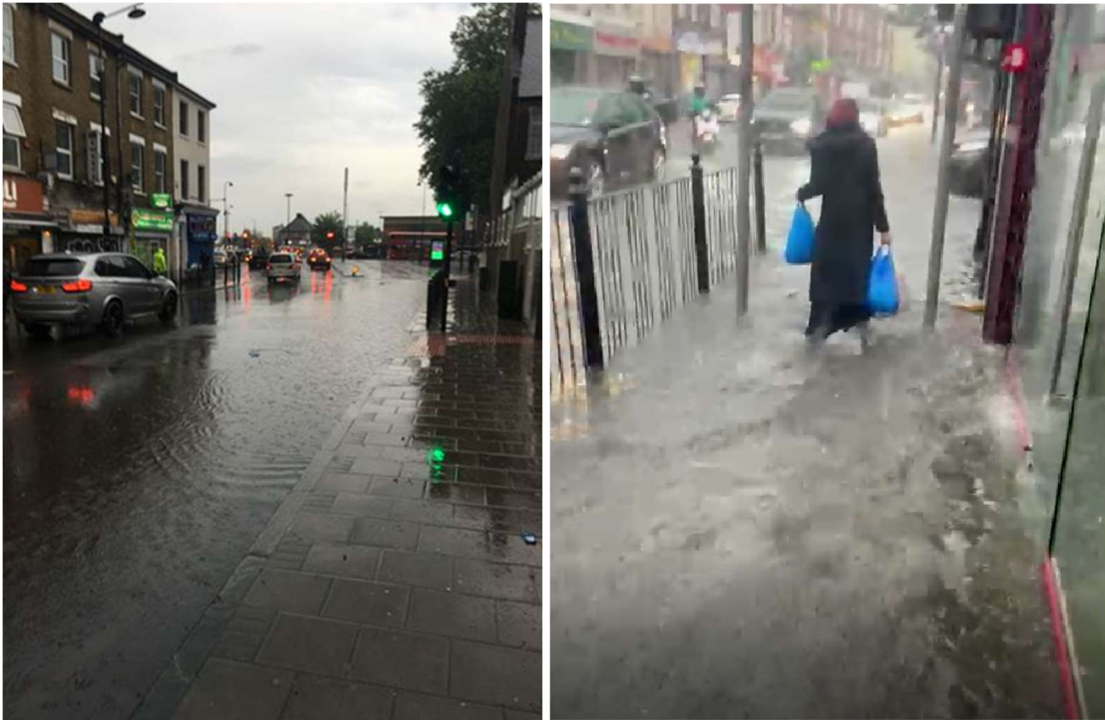
Video footage was received of Turnpike Lane near its junction with Willoughby Road at 19:21pm on 12th July 2021. The footage shows the carriageway and part of the adjacent footways inundated with water up to up to approximately 400mm deep. Pedestrians are observed ankle deep in water, with one observed attempting to unblock a drain along the main road. Vehicles continue to pass creating bow waves which wash the flood waters further onto the footways. Commentary in the video indicates that the flood water is being washed into adjacent shops. A second video shows the flood waters covering the entire footway outside numbers 6-18 Turnpike Lane. Flood waters can be observed flowing into business premises at No. 16 Turnpike Lane. A social media report from the business owner of No. 1 Turnpike Lane described how flooding occurs from the manhole outside the business premises.

Figure 5-3 Flooding on Turnpike Lane, 12th July 2021

The video and anecdotal evidence strongly suggests that the primary cause of the flooding was excessive rainfall which exceeded the capacity drainage network in this area. The intensity of the rainfall meant that surface water was unable to enter the sewer network fast enough and accumulated in the topographical low points, which reached sufficient depths to enter property. The DWMP model outputs suggest that the limited receiving capacity of the sewers would have been the primary cause of flooding. This is supported by anecdotal evidence from a local business describing water escaping from a manhole on Turnpike Lane⁶. Further investigation would be required in the east of Turnpike Lane to identify whether the capacity issues were primarily due to the receiving capacity of the highway drains, the public sewer or both. It is also understood by Haringey Council that the sewers in this part of Turnpike Lane are relatively shallow; this would need to be confirmed by Thames Water. Other contributing factors to the extent (depth and magnitude) of flooding include:

- **Sewer incapacity**
Flooding was observed from manhole at No. 1 Turnpike Lane. Haringey Council have indicated that the 9 inch sewer along Turnpike Lane is very shallow with invert of the sewer just lower than the outlet from the gully pots. Haringey have noted via email (20/01/22) that that have been informed that during heavy rainfall, runoff cannot enter the gully pots as the sewer system is already in surcharge status. Potential for a foul connection has been identified by Haringey. Capacity of the storm sewer will be further compromised where there is a foul connection.

- **Bow wave effect**
Video footage from the 12th July flooding along Turnpike Lane indicated that larger vehicles moving through the flood water caused a bow wave effect. Anecdotal reports from local business confirmed that this led to further movement of water onto the footway and into properties.

- Thames Water to investigate presence of foul drainage connection to storm sewer and remove (if connection is identified) to reduce hydraulic load on storm sewer network. Given the observed surcharge status of the sewer and the manhole flooding outside No.1 Turnpike Lane, increase of sewer capacity at this location should be investigated by Thames Water.

- Haringey Council have noted that they will be undertaking increased frequency of gully pot cleaning along Turnpike Lane.
- Haringey Council to consider implementation of SuDS measures in the upslope catchment to reduce the amount of runoff reaching the location of flood risk.

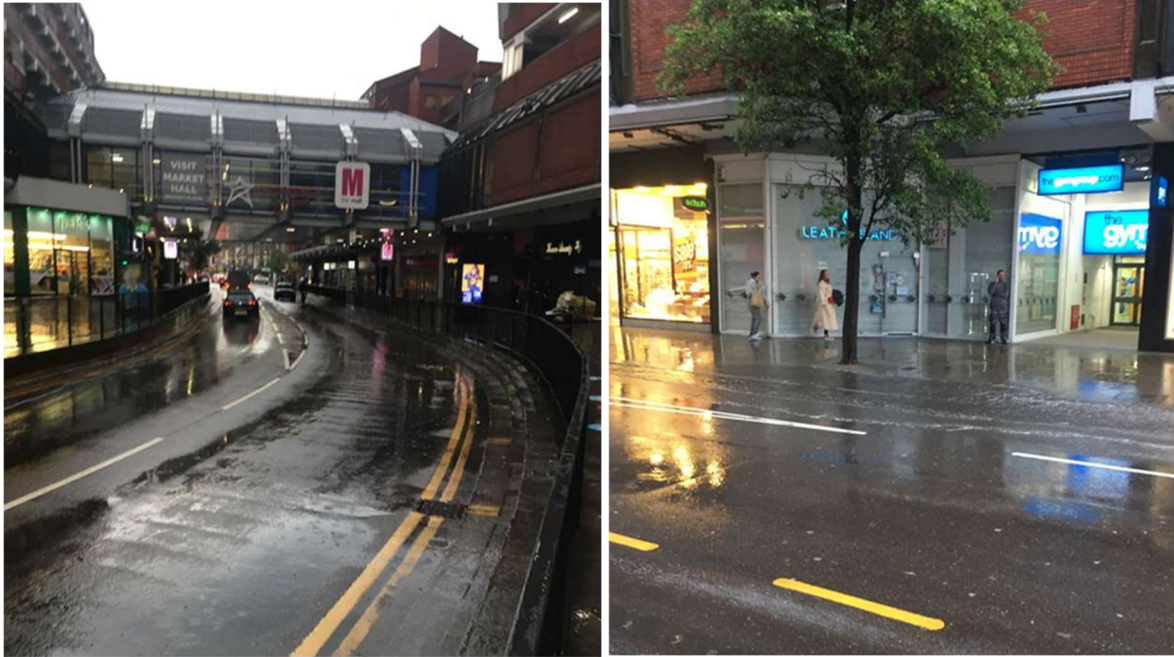
Reports of flooding were received from businesses in The Mall area of High Street, where major flooding of the highway was reported, and several businesses had contacted their insurance companies to deal with flood related damage. Photographs and videos circulated on social media indicated the spread and depth of flooding under the bridge within The Mall area. At 17:53pm on 12th July The Mall itself announced via social media that it had closed the centre due to the weather⁸.

Figure 5-5 Flooding at The Mall, 12th July 2021

The photographic evidence, local topography and available flood reports suggest that the primary cause of the flooding was excessive rainfall which exceeded the capacity drainage network in this area. The intensity of the rainfall meant that surface water was unable to enter the sewer network fast enough and accumulated in the topographical low points on High Road within the vicinity of The Mall, causing flooding of the highway. Any surcharging or flooding of the Moselle Culvert may have increased flooding on the carriageways and footways. Further investigation would be required to identify whether the capacity issues were primarily due to the receiving capacity of the highway drains, the public sewer, the Moselle Brook Culvert, or a combination.

It was noted that kerb sections to the north and south of The Mall were flush or 6-25mm high upstands adjacent the carriageway. Any excess surface water may quickly pass onto footways and then to properties.

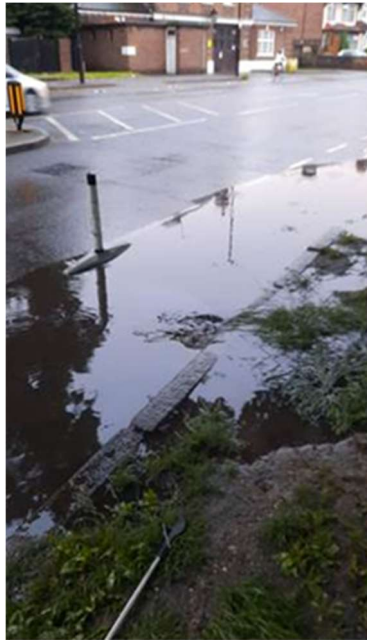
Flooding of the highway on Bounds Green Road was reported on 12th July, to which Haringey Council responded. The initial report was recorded as flooding having occurred outside 18 Trinity Road and at the junction of Bounds Green Road and Partridge Way. The photographic evidence of the call out indicates flooding at the junction of Bounds Green Road and Nightingale Road, near Bounds Green Ambulance Station.

Figure 5-7 Flooding at Bounds Green Road (junct Nightingale Road), 12th July 2021

The photographic evidence showing localised flooding and follow up reporting from Haringey Council suggests that the primary cause of the flooding at the Bounds Green Road / Nightingale Road junction was caused by a blocked gully limiting the rate at which surface water could enter the local drainage system.

Reported flooding is located at the crossing of the Muswell Stream Culvert. Surcharging of this culvert may have caused or exacerbated flooding locally on the carriageway and footway. Further investigation would be required to confirm.

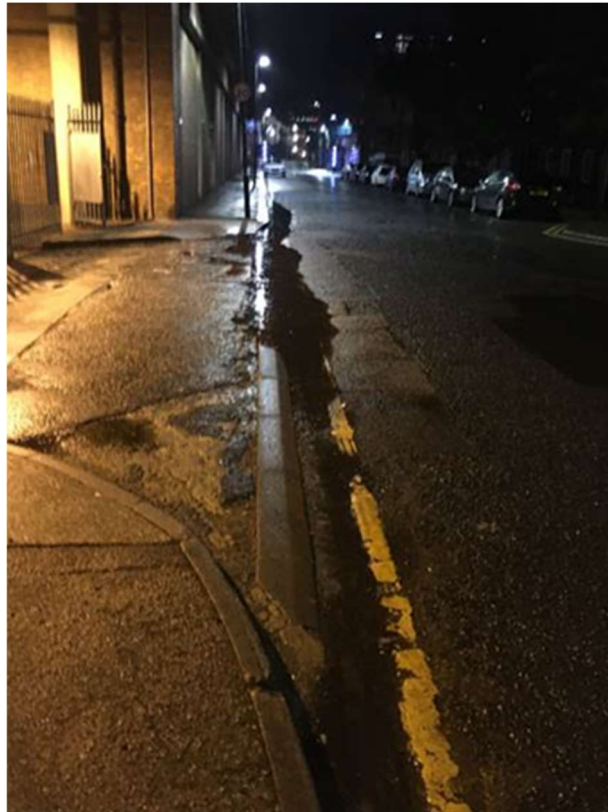
Flooding at Bury Road car park was reported on 12th July, to which Haringey Council responded. The initial report was recorded as flooding of the car park. By the time Haringey Council attended site on the evening of 12th July, most of the floodwater had dissipated, with some residual surface water noted at the car park entrance. Inspection of the gullies was instructed. The flood report schedule indicates no further action was taken.

Figure 5-9 Remaining flood water at Bury Road car park, 12th July 2021

The section of carriageway adjacent to the frontage of Bury Road car park is drained by 1 no. gully, and historic photographs show that standing water along the front of the car park, where cracking and deterioration of the carriageway edge is also visible. No information has been obtained related to internal building drainage.

The photographic evidence and follow up reporting from Haringey Council suggests that the primary cause of the flooding was excessive rainfall which exceeded the capacity drainage network in this area. The intensity of the rainfall meant that surface water was unable to enter the sewer network fast enough and accumulated along the frontage of Bury Road car park, eventually passing into the car park. Further investigation would be required to identify whether the capacity issues were primarily due to the receiving capacity of the highway drains, the public sewer, or both.
