# Section 19 Flood Investigation Report

## South Tottenham, London Borough of Haringey

M01600-15\_DG01 | January 2022

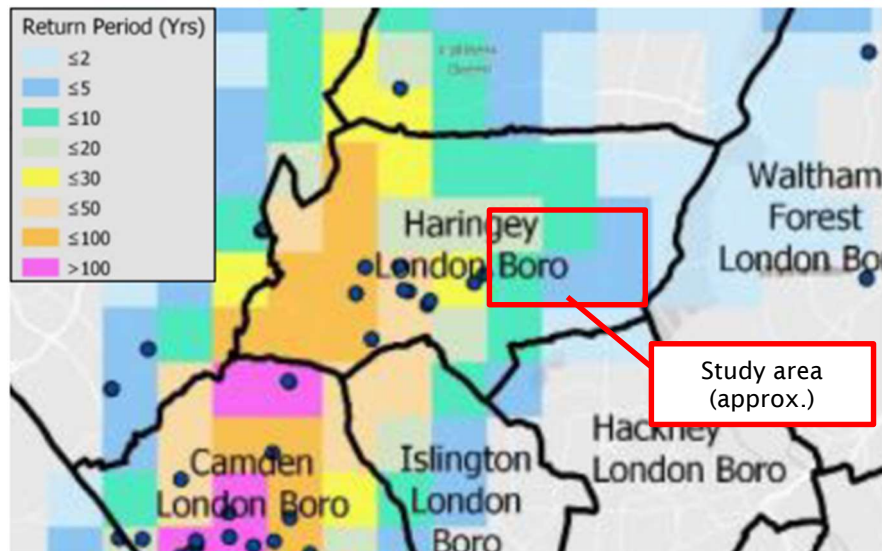
The relatively low rainfall recorded above is not consistent with the flood reports and anecdotal evidence provided from the area. The Hornsey gauges were blocked on retrieval of data and the recordings conflict with the Thames Water analysis of the rainfall event, which was presented at a recent workshop related to the floods<sup>6</sup>, and indicated that the district received rainfall return periods ranging from a <5 year to a <20 year rainfall event. The areas in which the gauges are located in Brent (Borough) and Wanstead (London Borough of Redbridge) did not experience the same intensity of rainfall experienced elsewhere, which concurs with the relatively low estimated rainfall return period derived from the rain gauge data for these locations.

**Figure 4-3 Rainfall Return Period and Report Flooding Incidents, 12<sup>th</sup> July 2021 (RaRa data using FEH99).**

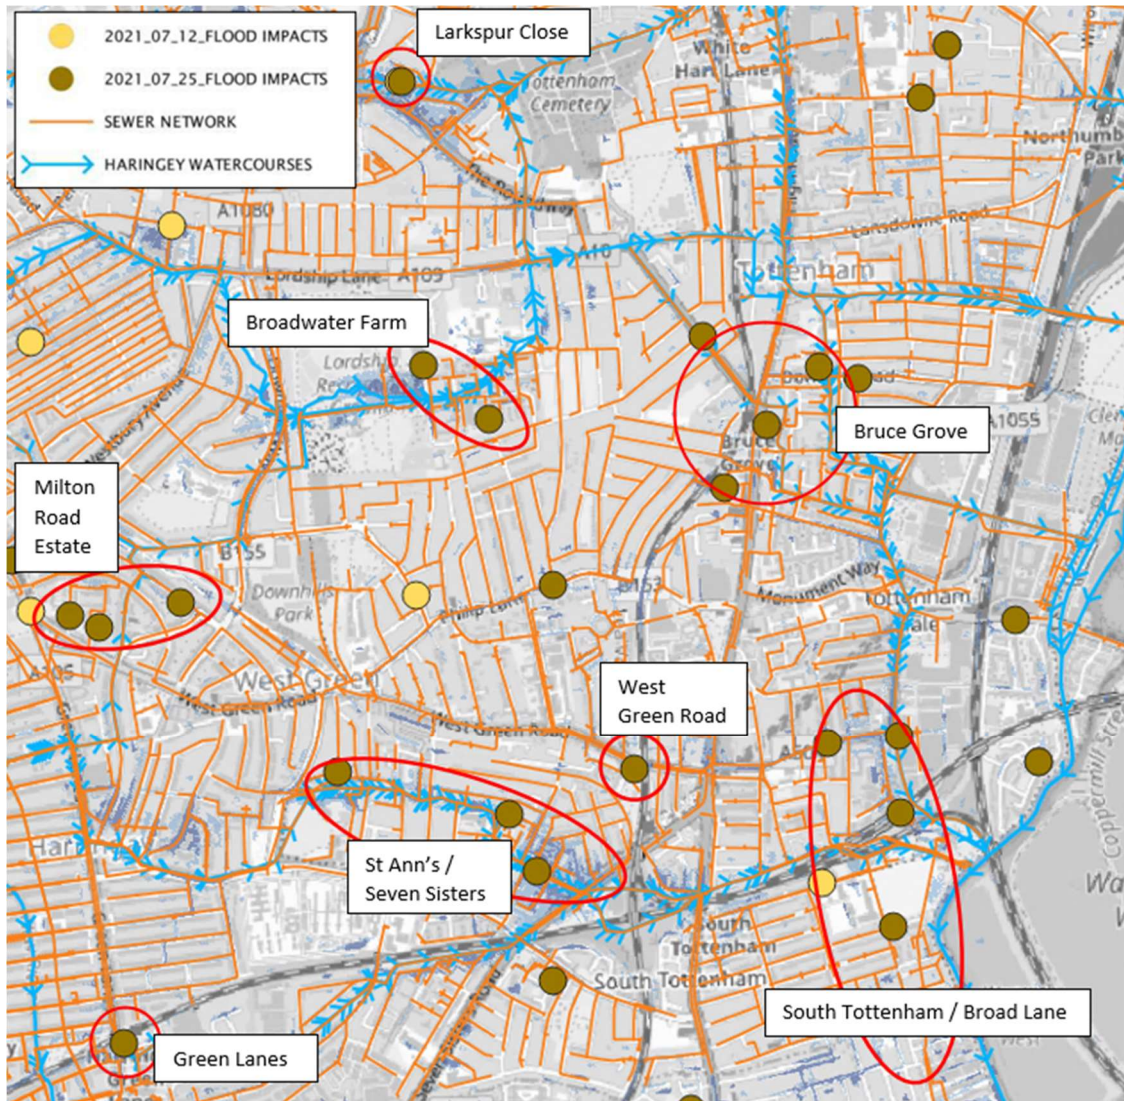
Figure 5-1 presents an overlay of flood reports from Haringey Council's Reported Flooding Impacts Mapping and highlights the areas of interest where an increased number of flood incidents were reported. Note that screened out locations also appear in this figure.

**Figure 5-1 Recorded flood impacts and areas of interest in South Tottenham**

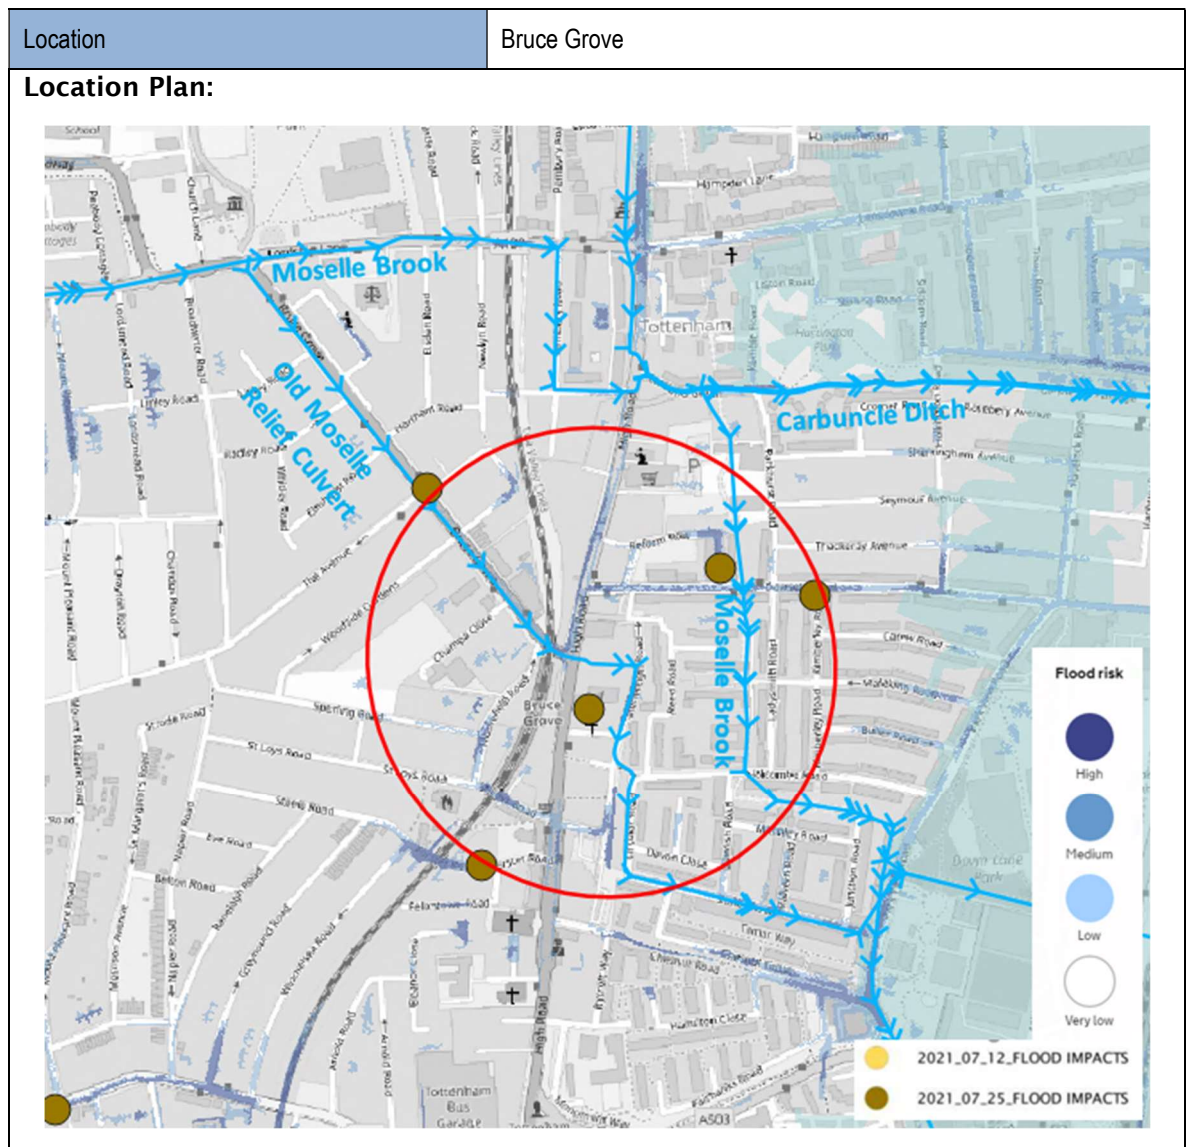
Figure 5-2 Site Location

The site context and anecdotal evidence suggests that the primary cause of the flooding was excessive rainfall which exceeded the capacity of the drainage network in this area. The intensity of the rainfall meant that surface water was unable to enter the sewer network fast enough and accumulated in the topographical low sections of Moorefield Road, St Loys Road and High Road. From here water levels were able to rise, encroaching into adjacent businesses and flowing into adjoining streets to the east. Surface water

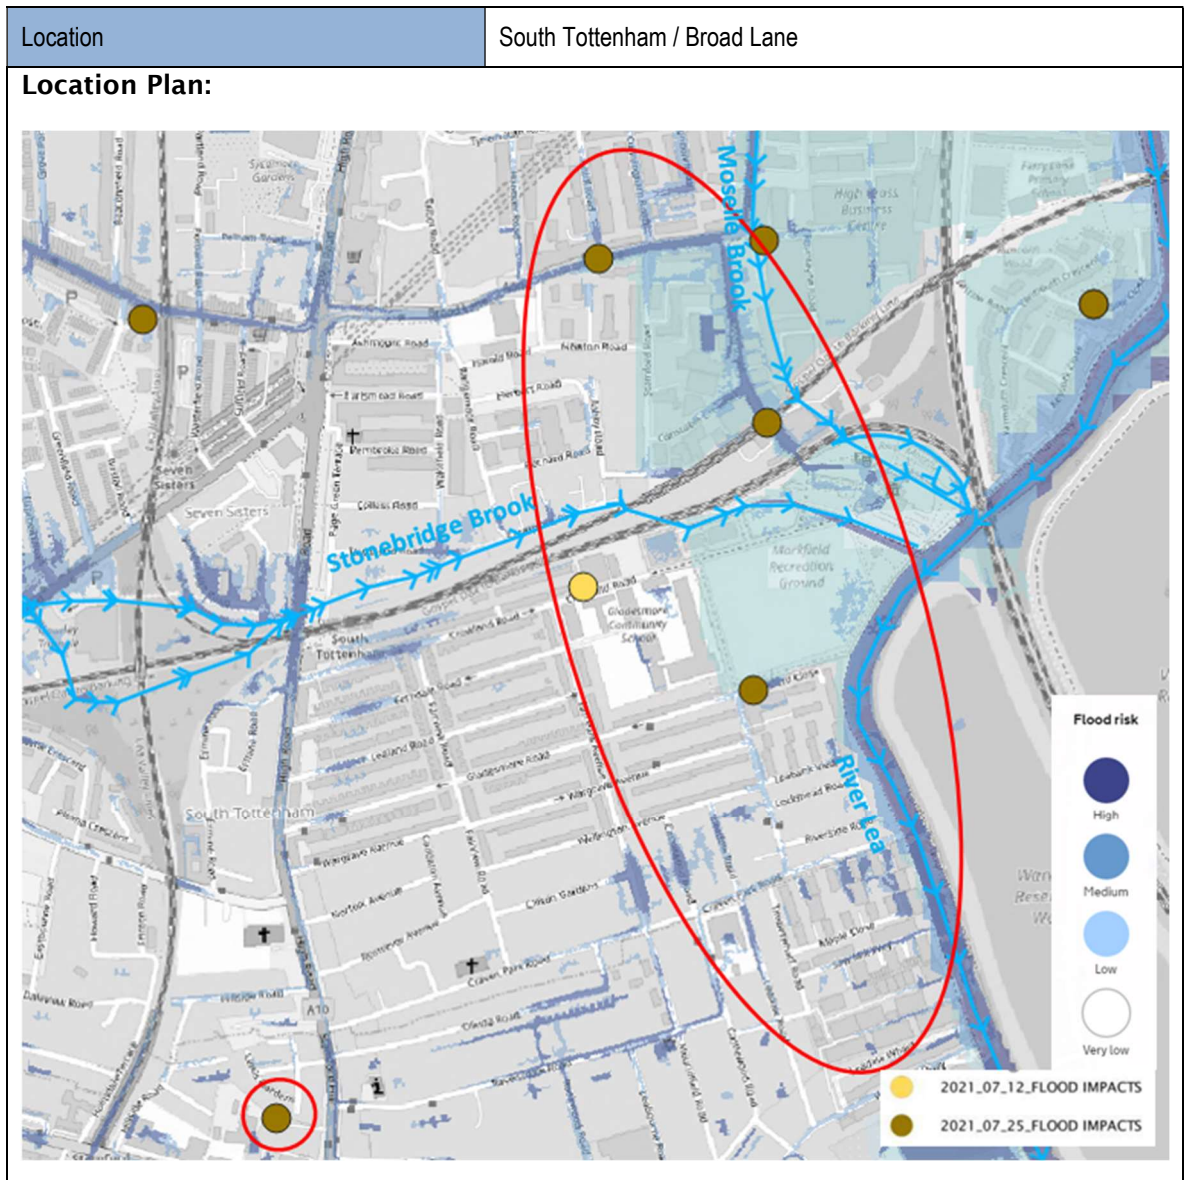
Figure 5-5 Site Location

The only reported emergency call on 12<sup>th</sup> July, as shown in Figure 5-5, was from Crowlands Road Primary School. Haringey Council recorded that the cause of flooding was due to an issue with an existing pipe issue and not rainwater, therefore this location is screened out of the investigation.

In Broad Lane and Markfield Road, the topography, existing sewer and culvert network (and DWMP outputs) and connections to the River Lee suggests that the primary cause of flooding was excessive rainfall which exceeded the capacity of the drainage network in the area. The rise in water levels in the River Lee would have increased surcharging of the sewer and culvert network; this in combination with the intensity of the rainfall meant that it accumulated on the surface, flooding the carriageway.

In Elm Park Avenue and the neighbouring streets, the photographs and DWMP outputs strongly suggest that the primary cause of the flooding was the limited receiving capacity of the sewers. The intensity of the rainfall meant that surface water was unable to enter the sewer network fast enough and accumulated in the topographical low sections of Elm Park Avenue, Clifton Gardens, Grovelands Road and Lemsford Close.

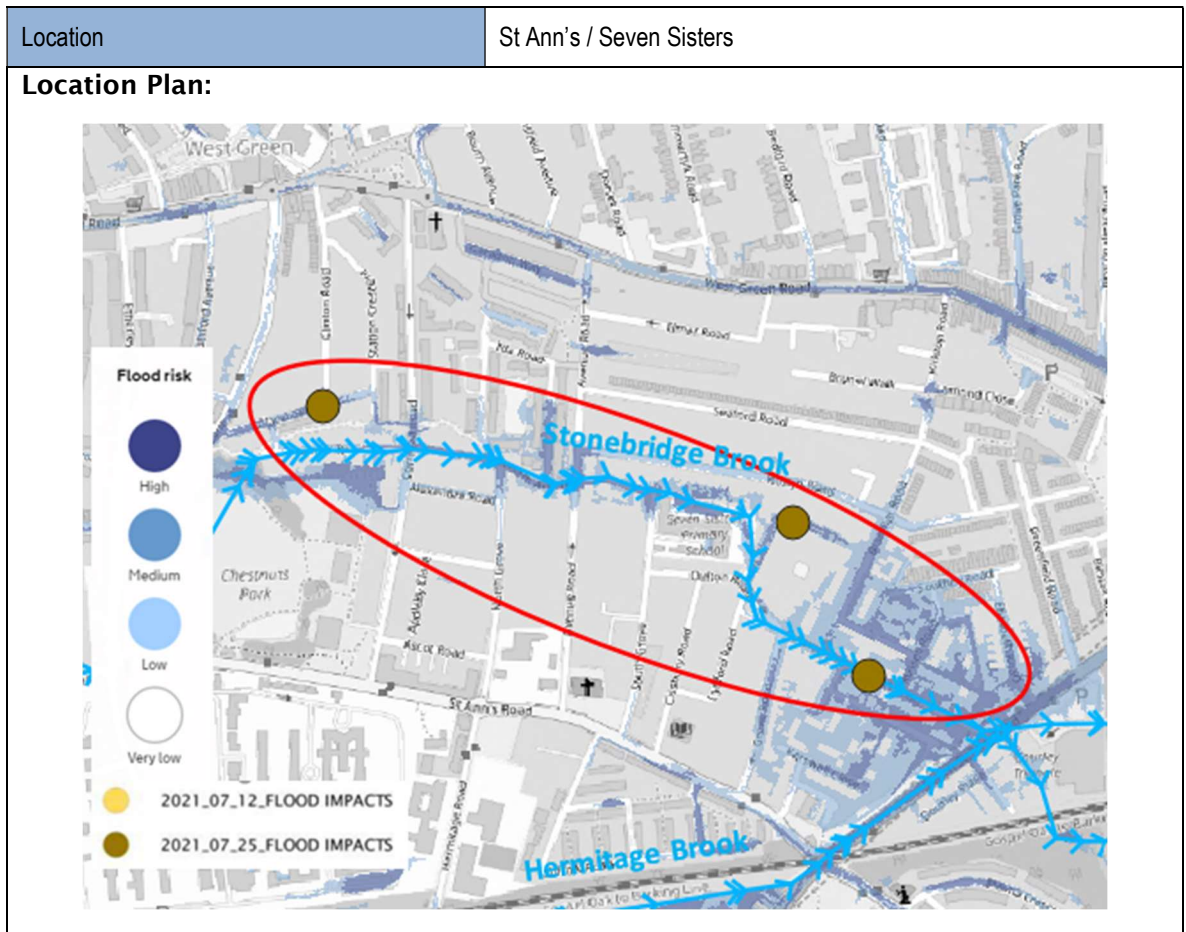
Figure 5-8 Site Location

The photographs, flood reports and DWMP output strongly suggest that the primary cause of the flooding was an exceedance of the capacity of the drainage network and culverts in this area, caused by the excessive rainfall which fell on the day. The intensity of the rainfall meant that surface water was unable to enter the sewers and culverted watercourses fast enough and accumulated in the topographical low points, flooding the highways and adjacent properties. The DWMP model outputs suggest that the limited receiving capacity

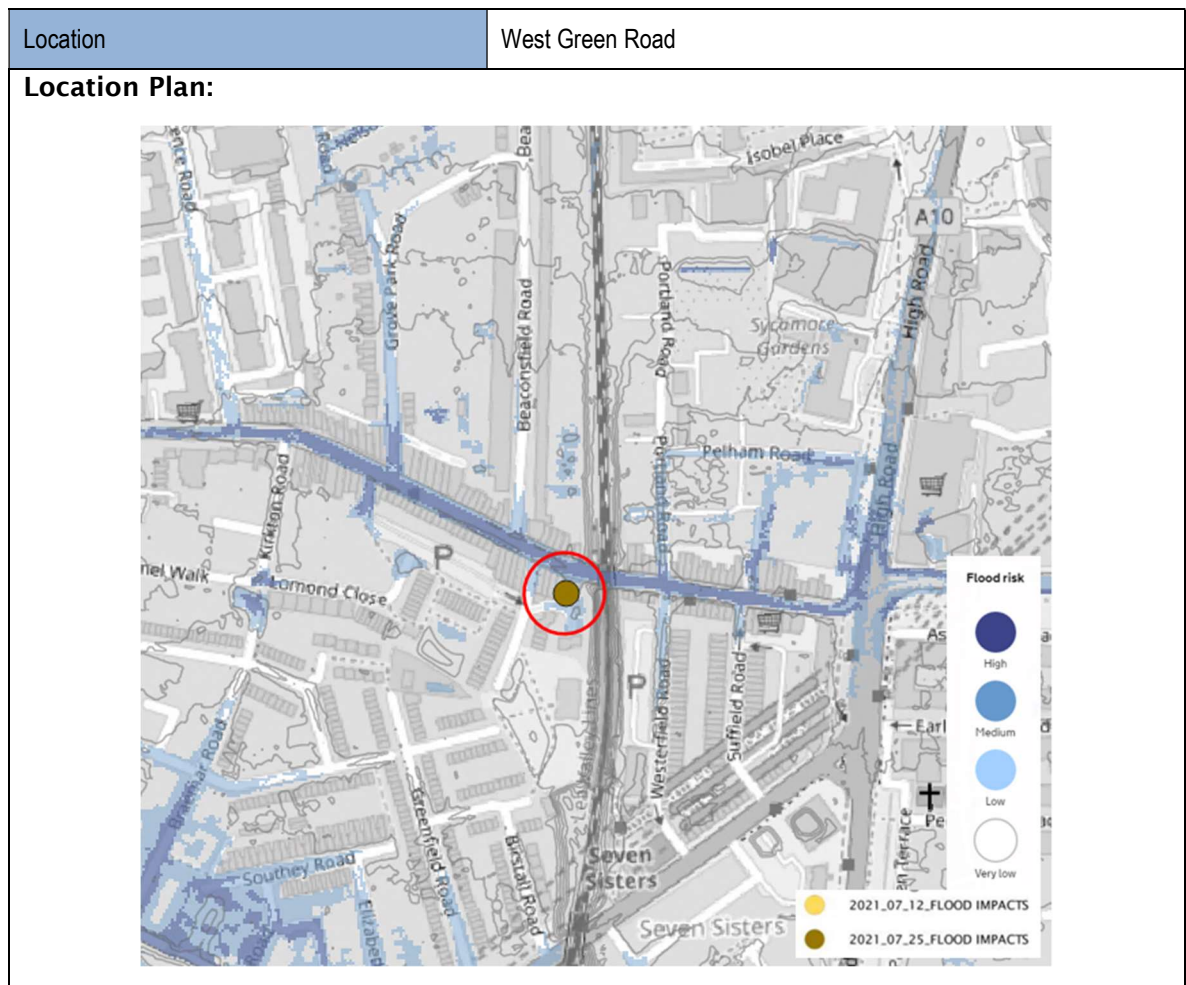
Figure 5-10 Site Location

The photos and site evidence strongly suggest that the primary cause of the flooding was exceedance of the capacity of the surface water sewers in West Green Road. Surface water was unable to enter the sewer network fast enough and accumulated in the low-lying area along West Green Road, which reached sufficient depths to flood the highway and enter property. The DWMP model outputs suggest that the limited receiving capacity of the sewers would have been the primary cause of flooding. Observations during the site walkover support this; frequent gully positions were identified at the low spot of the railway underpass (14 no. across 12m of carriageway) but flooding was not prevented. Further investigation would be required throughout this low lying section of West Green Road to identify whether the capacity issues were entirely due to the receiving capacity of the public sewer or whether the capacity of the highway drains was a contributing factor. Other contributing factors to the extent (depth and magnitude) of flooding include:

- Haringey Council to consider localised temporary road closures or diversions in high-risk areas with low profile kerbs to reduce ingress of floodwaters onto footways and into properties where risk of internal flooding is caused by bow wave affect from the movement of vehicles through flood waters.

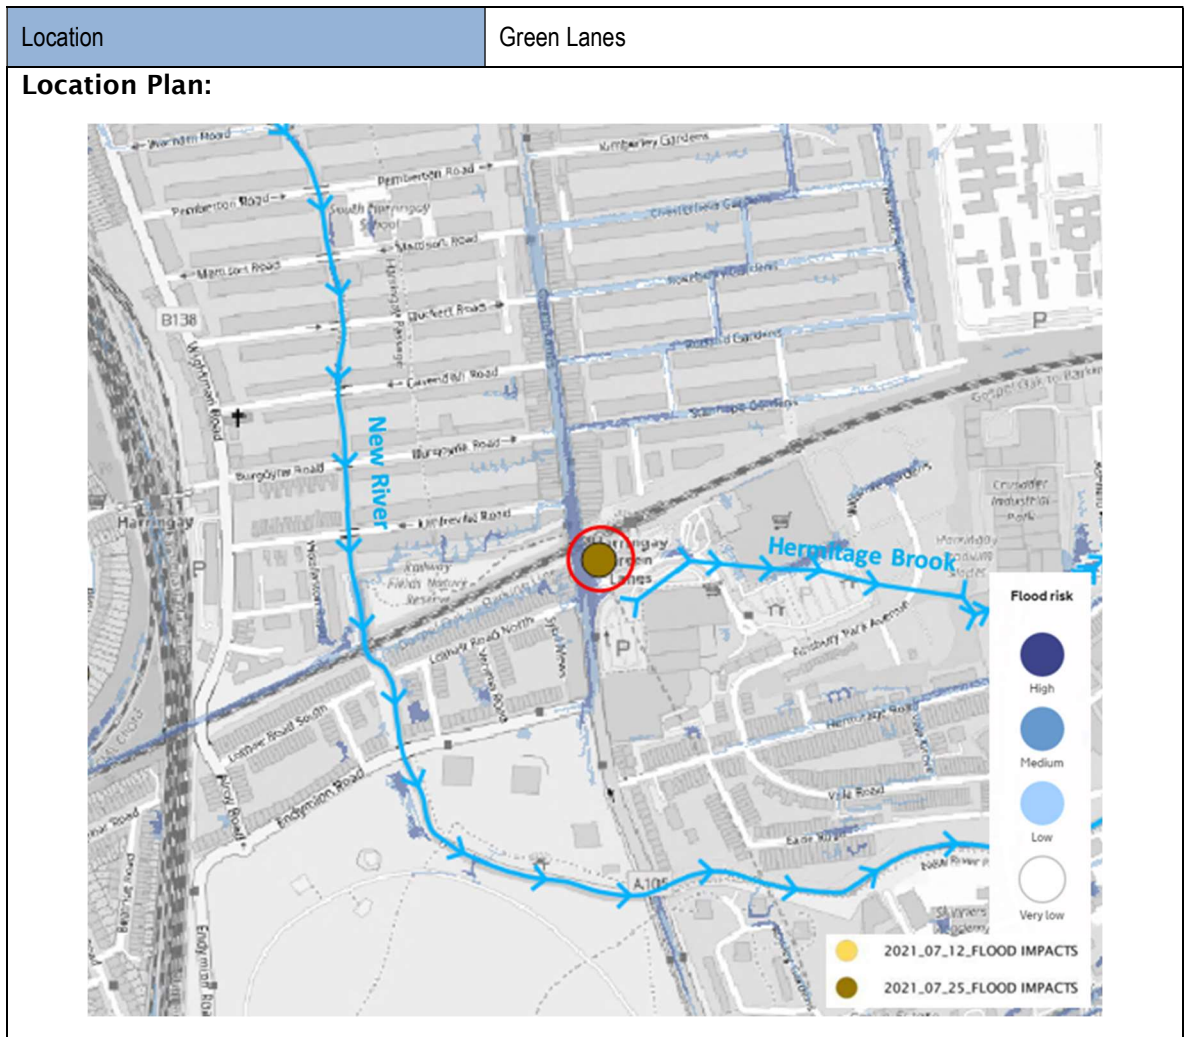
Figure 5-12 Site Location

The photos and flood report schedule suggests that the primary cause of the flooding was exceedance of the capacity of the surface water sewers in Green Lanes. Surface water was unable to enter the sewer network fast enough and accumulated in the low-lying area along West Green Road, which reached sufficient depths to flood the highway and businesses. The DWMP model output shows a risk of surface water escaping from manholes during a 1 in 30 year event. This is supported by the flood report of manholes being lifted. Further investigation would be required in throughout the section of Green Lanes south of the underpass to identify whether the capacity issues were entirely due to the receiving capacity of the public sewer or whether the capacity of the highways was a contributing factor.
