Section 19 Flood Investigation Report

Wood Green

London Borough of Haringey

M01600-13_DG01 | January 2022

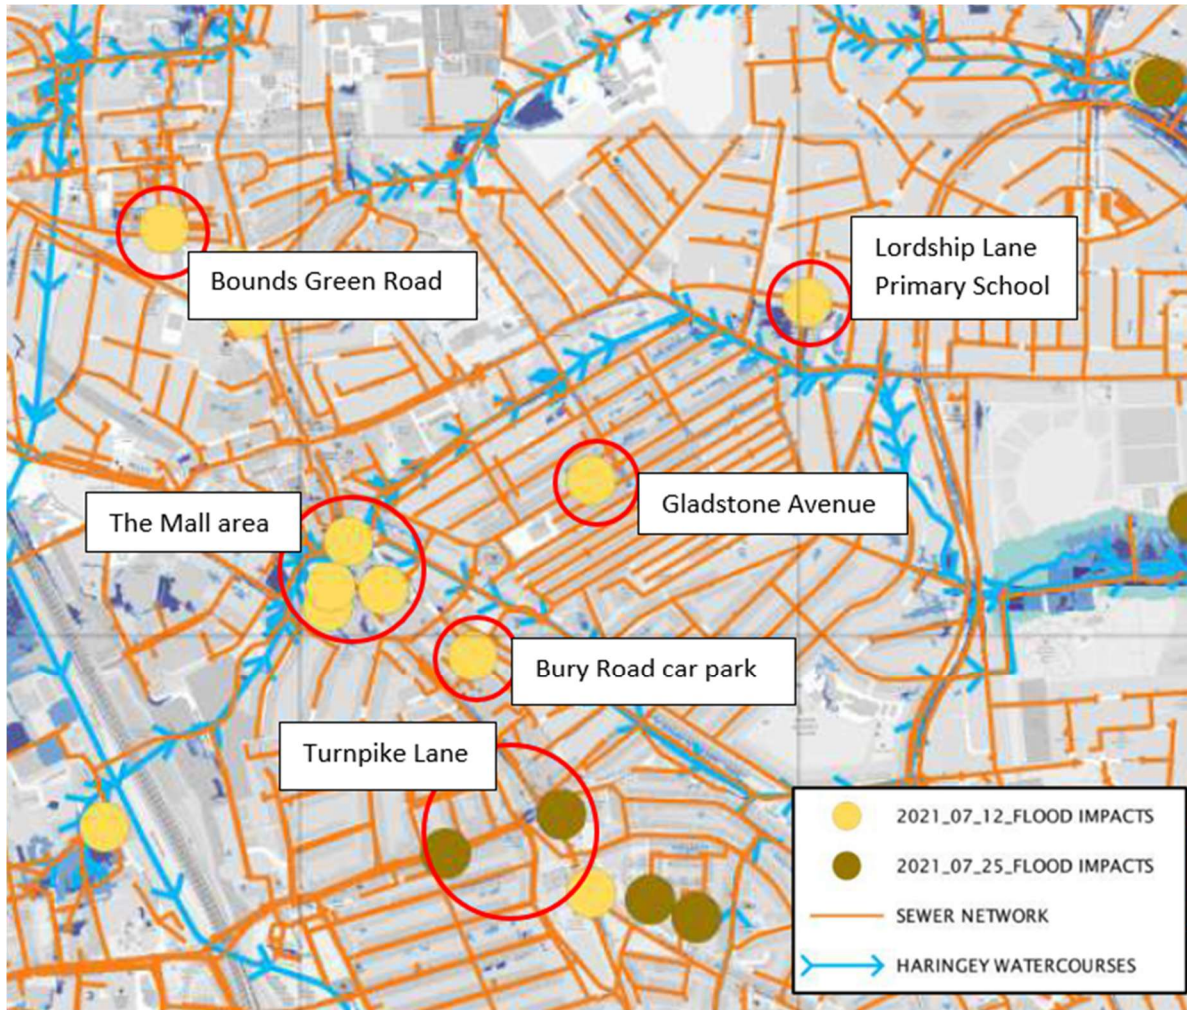
Figure 5-1 Recorded flood impacts and areas of interest in Wood Green, 12th July 2021

Figure 5-1 presents an overlay of flood reports from Haringey Council's Reported Flooding Impacts Mapping and highlights the areas of interest where an increased number of flood incidents were reported. Note that screened out locations also appear in this figure.

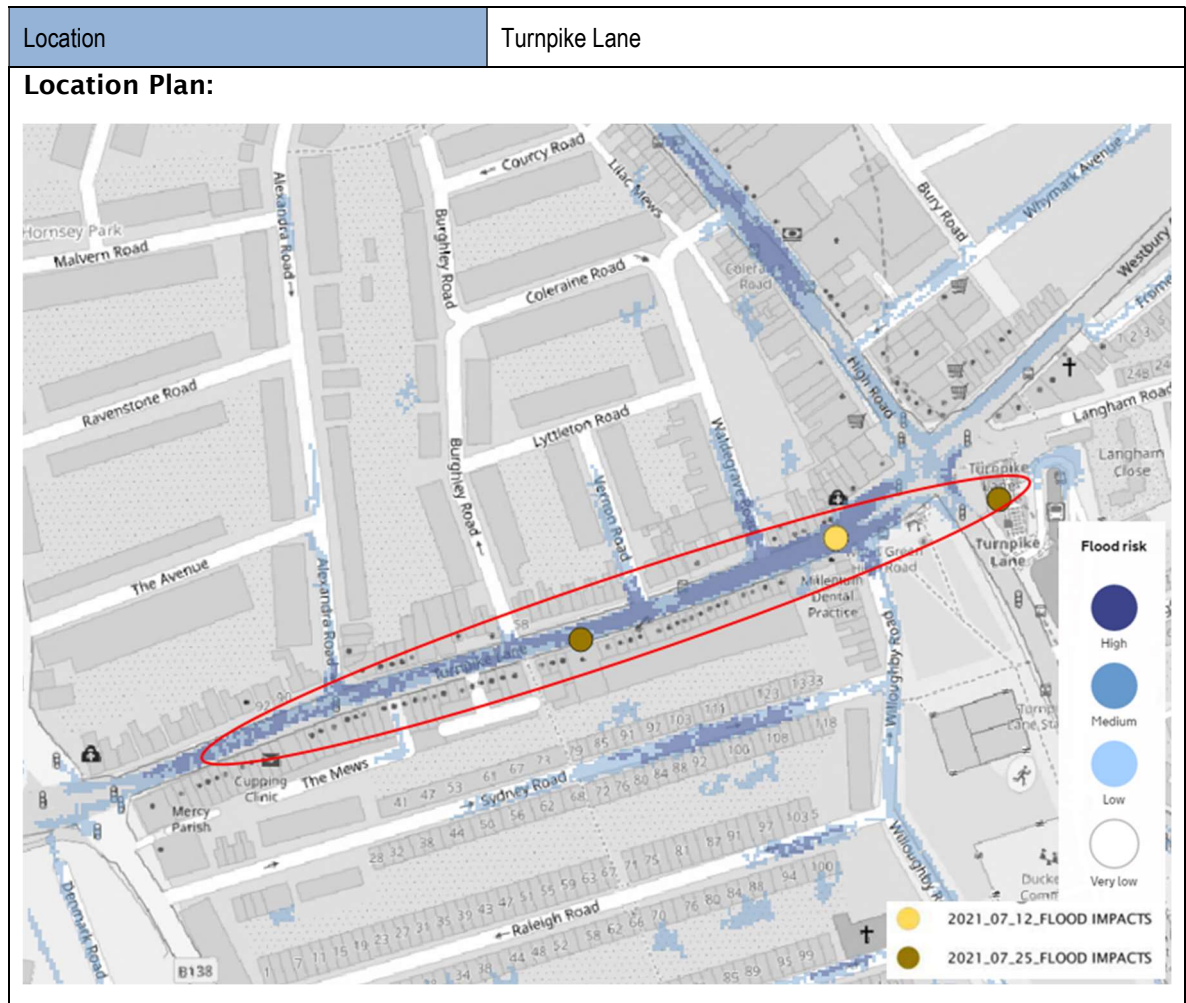
Figure 5-2 Site Location

Video footage was received of Turnpike Lane near its junction with Willoughby Road at 19:21pm on 12th July 2021. The footage shows the carriageway and part of the adjacent footways inundated with water up to up to approximately 400mm deep. Pedestrians are observed ankle deep in water, with one observed attempting to unblock a drain along the main road. Vehicles continue to pass creating bow waves which wash the flood waters further onto the footways. Commentary in the video indicates that the flood water is being washed into adjacent shops. A second video shows the flood waters covering the entire footway outside numbers 6-18 Turnpike Lane. Flood waters can be observed flowing into business premises at No. 16 Turnpike Lane. A social media report from the business owner of No. 1 Turnpike Lane described how flooding occurs from the manhole outside the business premises.

The eastern extent of Turnpike Lane, between the junctions with Burghley Road and Willoughby Road, is the lowest section along the Lane at approximately 23.0mAOD. Turnpike Lane falls from circa 34mAOD near the railway bridge in the west to this point. Further east the road rises again to the junction with Westbury Avenue, Green Lanes and High Road. The surface water flood map in Figure 5-2 indicates the risk in this area is due to the number of flow routes converging in this area, with limited ability for the water to flow away over the ground.

The video and anecdotal evidence strongly suggests that the primary cause of the flooding was excessive rainfall which exceeded the capacity drainage network in this area. The intensity of the rainfall meant that surface water was unable to enter the sewer network fast enough and accumulated in the topographical low points, which reached sufficient depths to enter property. The DWMP model outputs suggest that the limited receiving capacity of the sewers would have been the primary cause of flooding. This is supported by anecdotal evidence from a local business describing water escaping from a manhole on Turnpike Lane⁶. Further investigation would be required in the east of Turnpike Lane to identify whether the capacity issues were primarily due to the receiving capacity of the highway drains, the public sewer or both. It is also understood by Haringey Council that the sewers in this part of Turnpike Lane are relatively shallow; this would need to be confirmed by Thames Water. Other contributing factors to the extent (depth and magnitude) of flooding include:

- **Sewer incapacity**
Flooding was observed from manhole at No. 1 Turnpike Lane. Haringey Council have indicated that the 9 inch sewer along Turnpike Lane is very shallow with invert of the sewer just lower than the outlet from the gully pots. Haringey have noted via email (20/01/22) that that have been informed that during heavy rainfall, runoff cannot enter the gully pots as the sewer system is already in surcharge status. Potential for a foul connection has been identified by Haringey. Capacity of the storm sewer will be further compromised where there is a foul connection.

- **Bow wave effect**
Video footage from the 12th July flooding along Turnpike Lane indicated that larger vehicles moving through the flood water caused a bow wave effect. Anecdotal reports from local business confirmed that this led to further movement of water onto the footway and into properties.

- **Threshold Heights**
During the site walkover it was noted that a number of properties in the affected area had flush front door thresholds. The flush threshold is a requirement for accessibility. This arrangement would allow for surface water to quickly enter properties once the footway had been submerged.

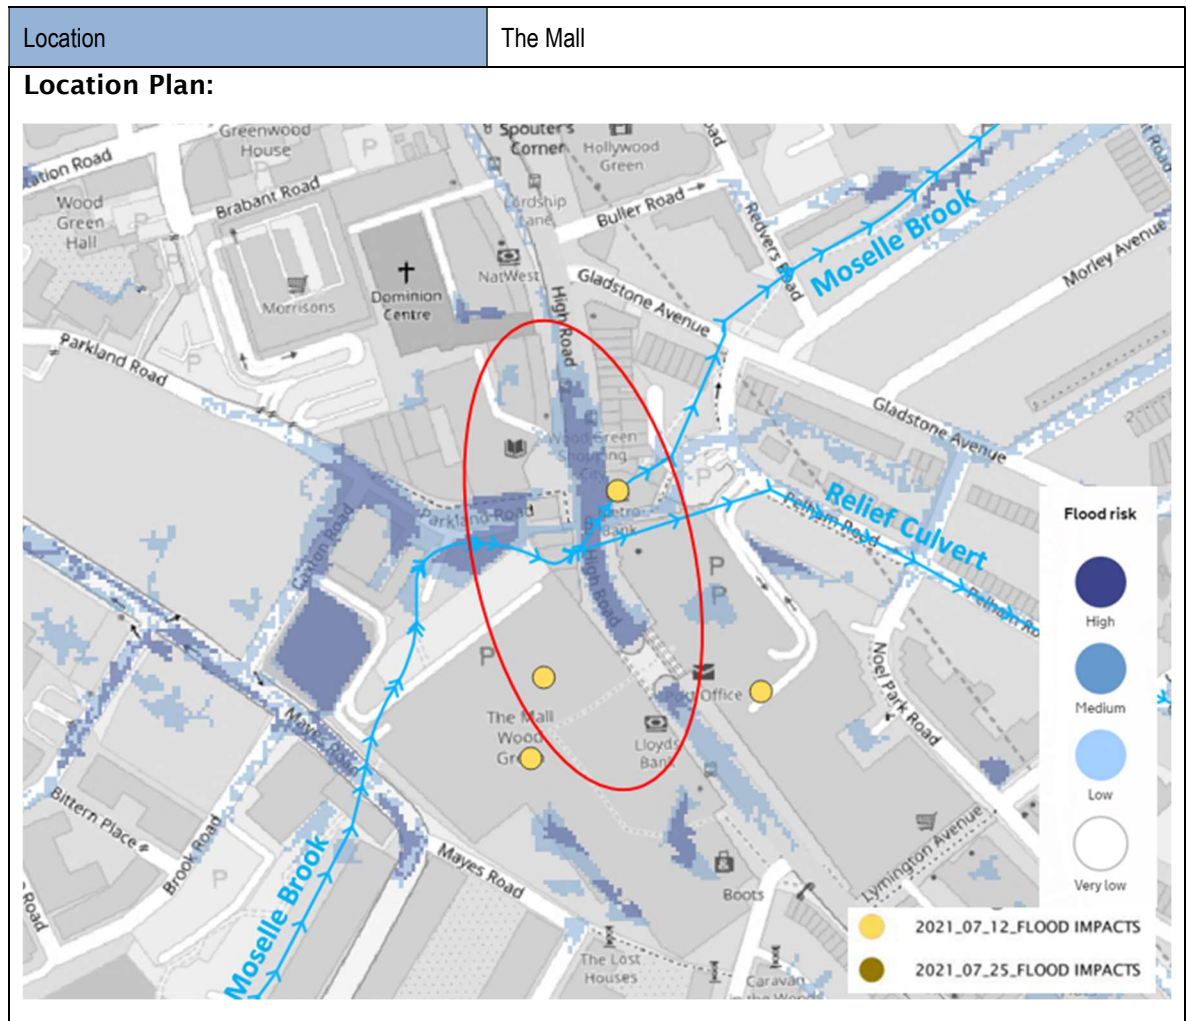
Figure 5-4 Site Location

High Road, which passes through The Mall under a pedestrian bridge (see Figure 5-3) falls in a southerly direction from a high area (circa 40mAOD) near the junction with Bounds Green Road in the north. The High Road generally falls all the way to its junction with Westbury Avenue and Turnpike Lane (20mAOD), but there is a localised low spot in the vicinity of The Mall at the pedestrian bridge underpass. The highest surface water risk, as shown on the surface water flood map in Figure 5-4, is consistent with this section. The carriageway under the pedestrian bridge is lower than the surrounding footways by up to 500mm and a total of 5 gullies are present over the 30m section of road under the bridge. Raised pedestrian crossings are located to the south and north of the pedestrian bridge, further confining surface water runoff within the underpass section. To the north and south of the underpass section, kerbs are either flush or have a 6-25mm high upstand from the carriageway.

It was noted that kerb sections to the north and south of The Mall were flush or 6-25mm high upstands adjacent the carriageway. Any excess surface water may quickly pass onto footways and then to properties.

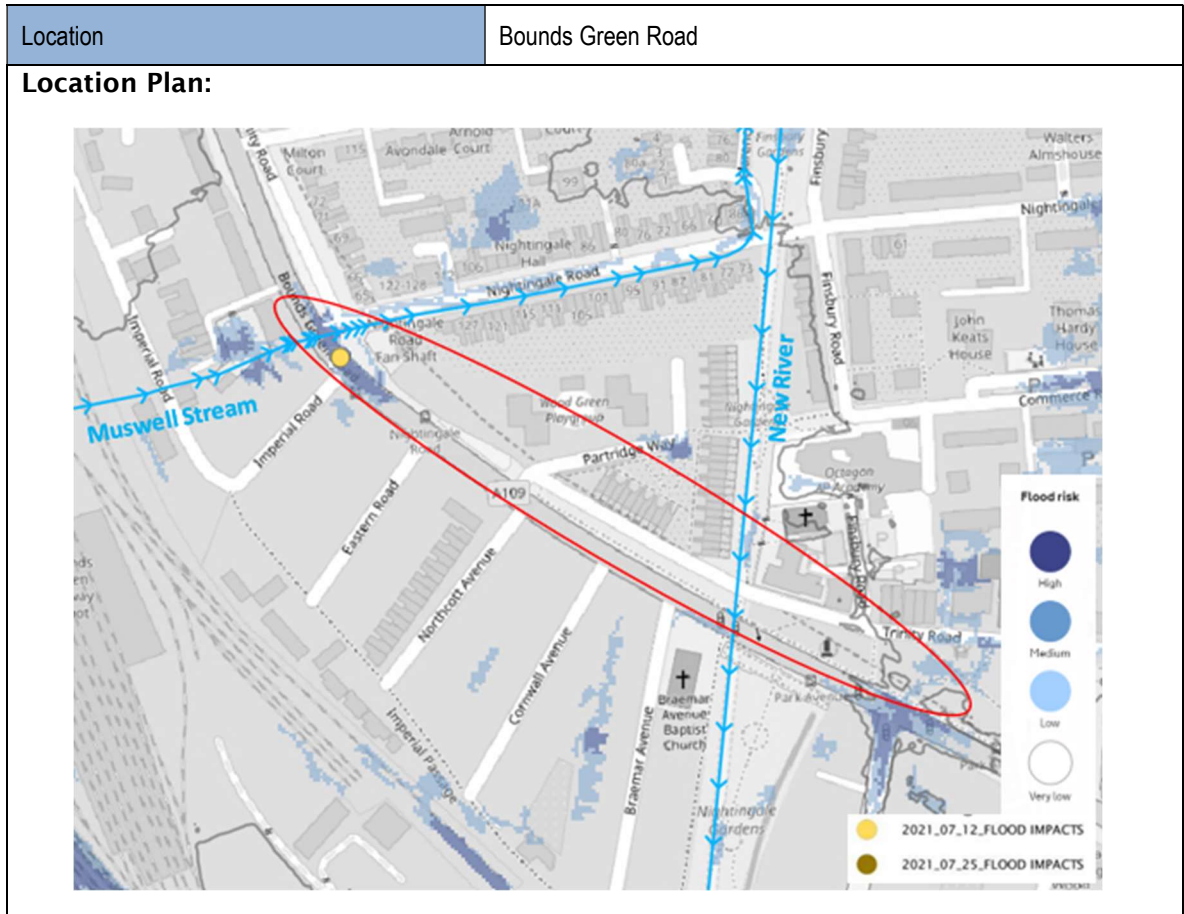
Figure 5-6 Site Location

Bounds Green Road generally falls from the Bowes Park railway overpass (circa 45mAOD) to its junction with High Road (32mAOD). There is a topographical low spot at its junction with Park Avenue. The EA maps (Figure 5-6) show two areas of high surface water risk along this section of Bounds Green Road; the junction with Park Avenue and junction with Nightingale Road. Bounds Green Road is a local distributor road with an average width of 12.5m in the area of interest.

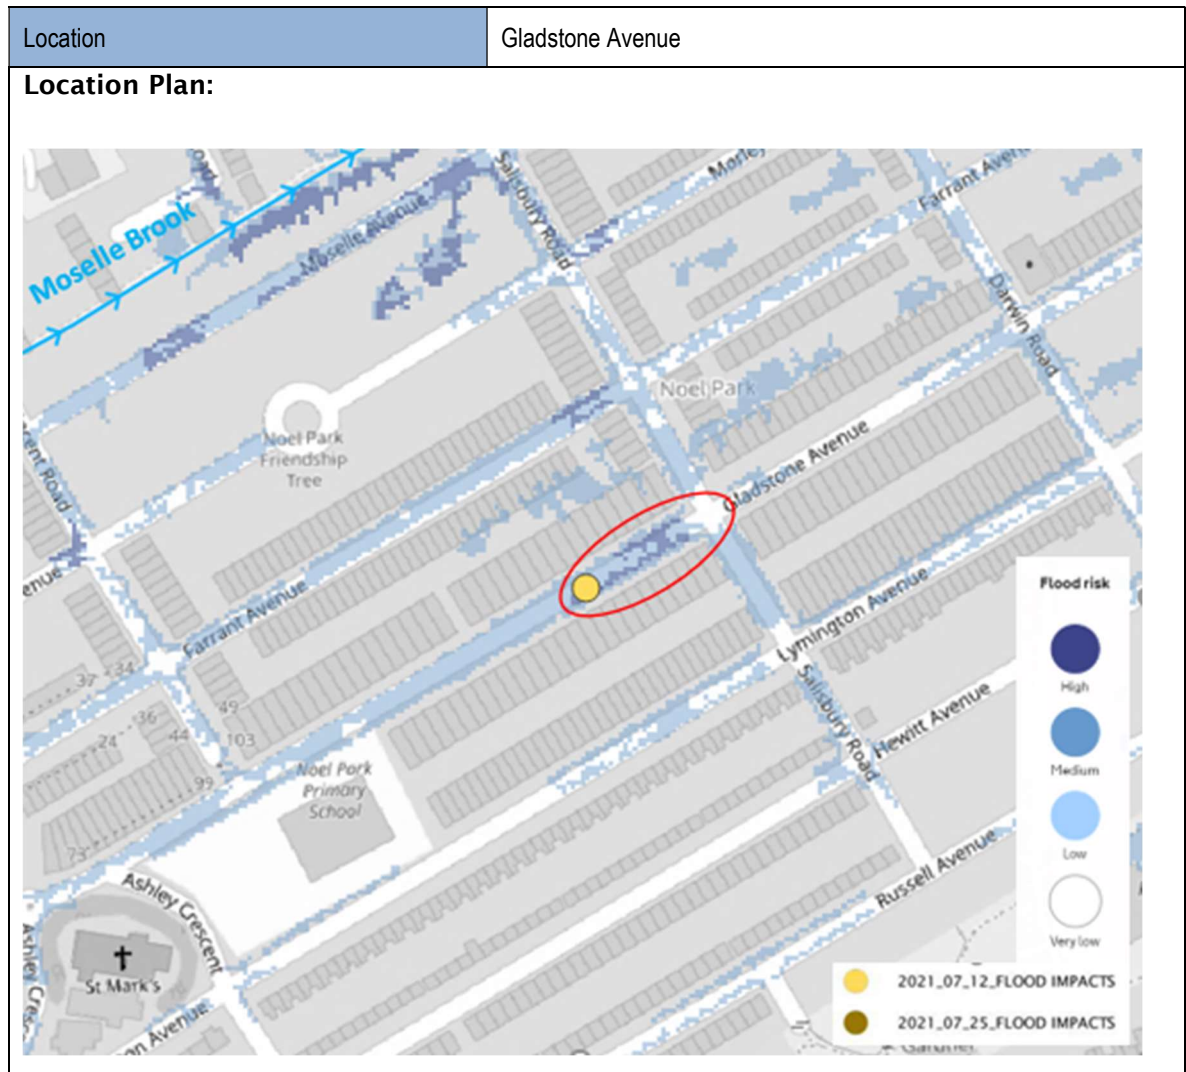
Figure 5-10 Site Location

Gladstone Avenue is a residential street which falls gently to the northeast between approximate elevations of 18mAOD and 17mAOD. The street comprises a series of speed humps along its length, and the junction with Salisbury Road is a raised table. This topography corresponds with the surface water flood risk map shown in Figure 5-10, in which it is suggested that surface water accumulates near the junction of the two carriageways.
